VAS581005

Welcome to the VAS581005

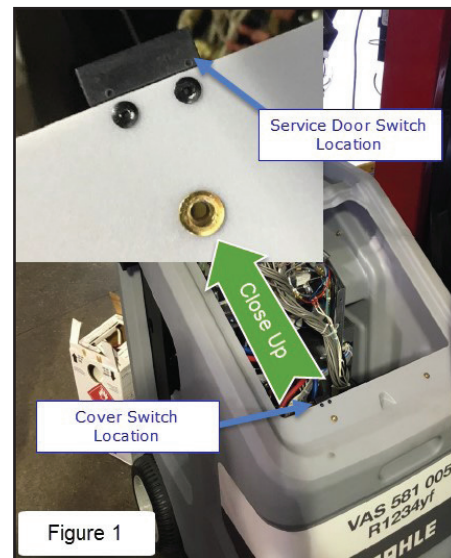
Figure 1

- If the unit will not power on, the breaker may have tripped. To reset, push the white breaker button on the lower rear of cabinet.
- If the service door is removed or opened, the unit will automatically stop all processes. The ventilation fan will remain in operation to ensure any R1234yf vapors are removed. See Figure 1.

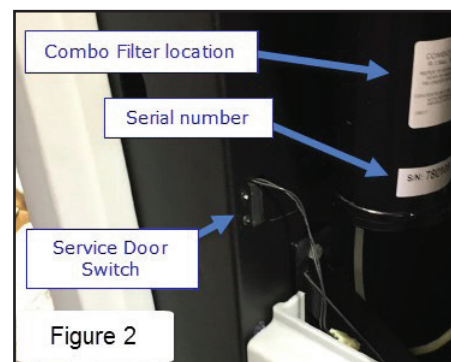
Figure 2

- The VAS581005 is locked and disabled after 150Lbs of refrigerant is processed. A new filter and 6 digit code must be installed before service can resume. See Figure 2.

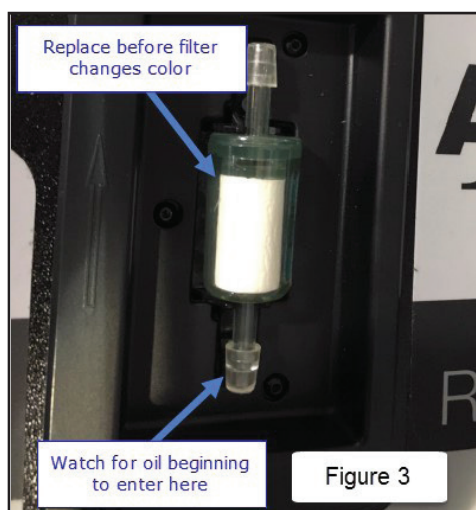
- See Figure 3 and 4. Replacing the white sample filter and hose on the refrigerant identifier if oil is present. Sample hose and brass restrictor can be cleaned with isopropyl alcohol as shown in Figure 5.
