Number: ATE-20-15

Subject: T40093/5 RECALL – Inspection Needed

Date: August 7, 2020

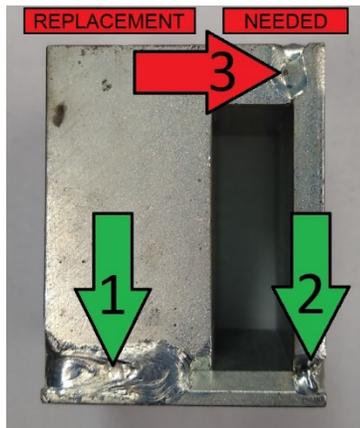
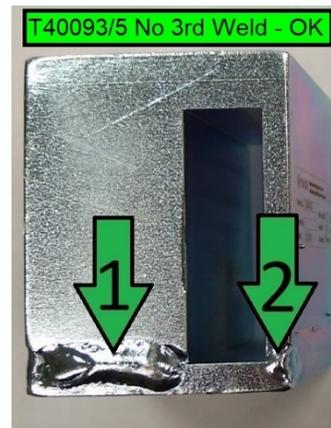
In the event of a complete malfunction of the T40093/5, the engine supported with T40093/5 will fall. Consequently, service personnel may sustain injuries and damage to the vehicle may occur. If the T40093/5 has the **third weld**, Please **DISCONTINUE USE IMMEDIATELY!** Set aside the effected T40093/5 for return and replacement.

The presence of a third weld indicates replacement is needed.

Please provide the requested information below and attach photos of YOUR T40093/5 whether or not it needs to be replaced.

1. Dealer Code
2. Manager/Foreman Name & DIRECT contact phone number
3. Manufacture Code
4. Number of T40093/5 that NEED REPLACED
5. Two photos of EACH T40093/5 - One Showing the **3rd WELD/Lack of 3rd weld**, and One of the **manufacture** code.

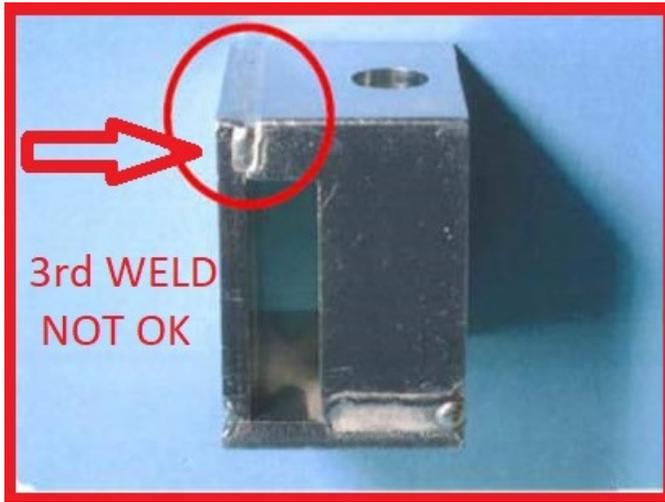
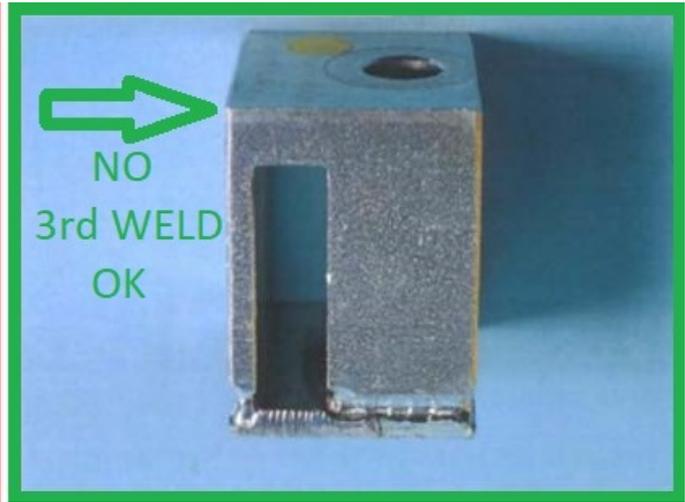
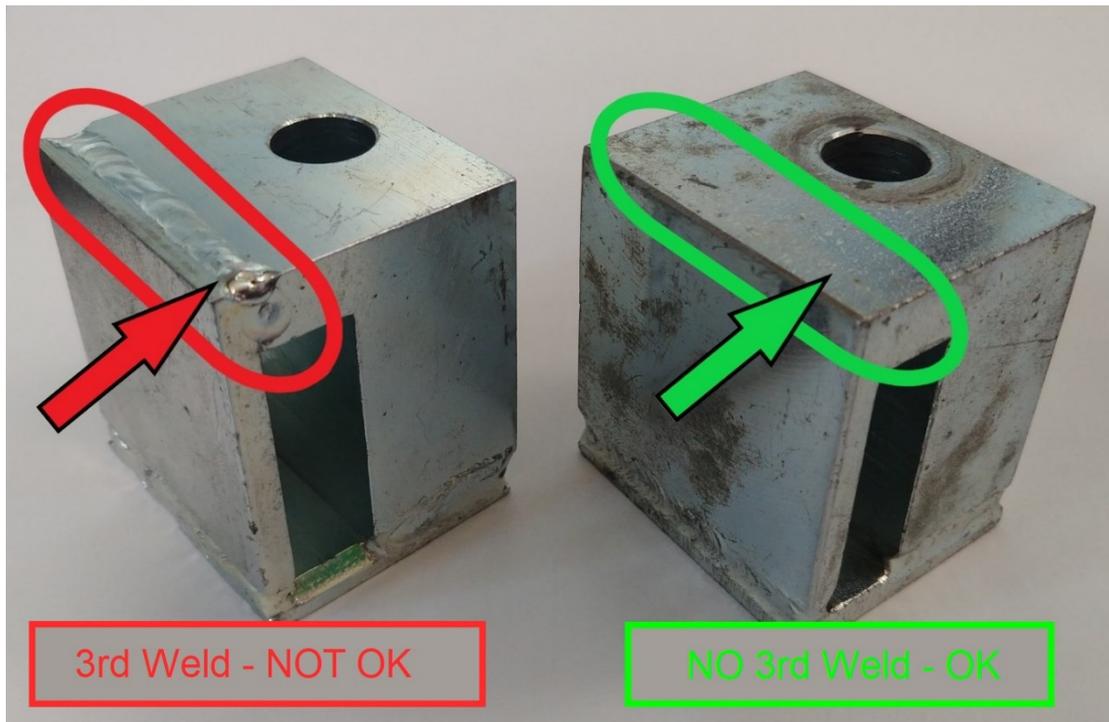
Please identify if your T40093/5 has the **third weld** as shown below, and identify as one of the following **manufactures**.

WEMA / MA

CI / MA

CE / MA

SPX / MA

Beissbarth-C49 / MA
