# Service Information

Number: ATE-24-12

Subject: VAS5581A Technical Product Service Information

Date: Sept. 25, 2024

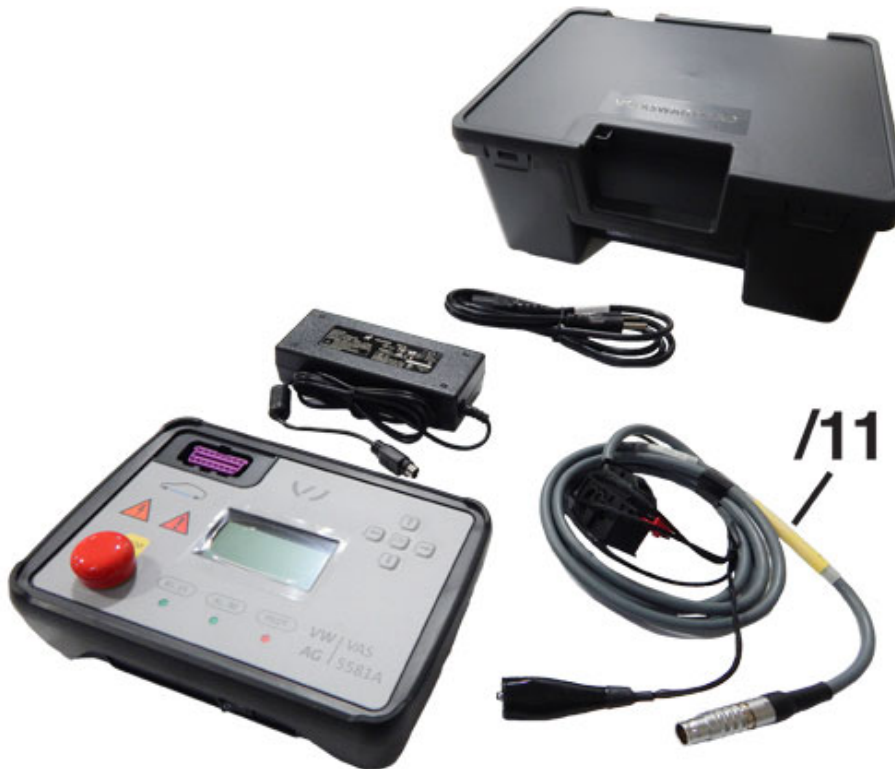
The VAS5581A has an internal battery that must stay charged. Keep the provided charger always plugged into the VAS5581A and a wall outlet.

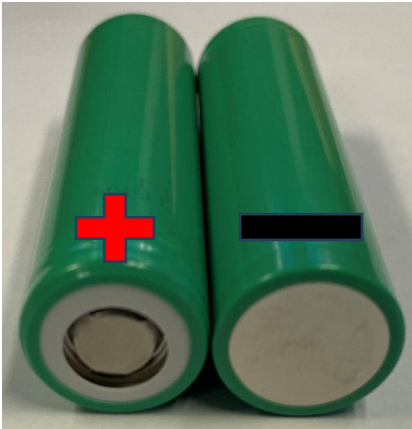
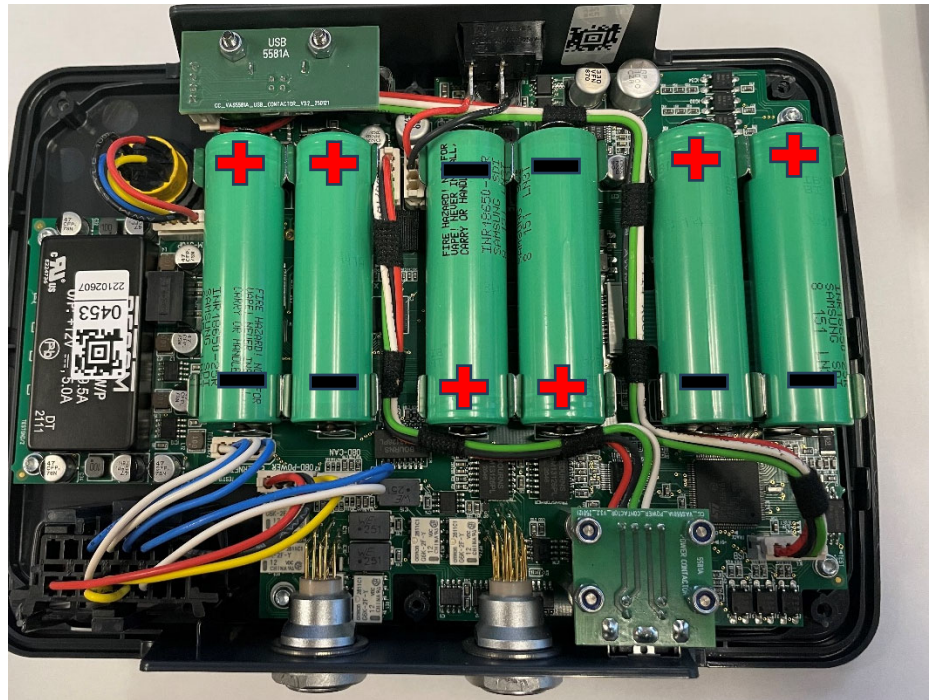
If the VAS5581A is no longer under warranty the 6 internal batteries can be replaced with **Samsung25R 3.7V Rechargeable 18650 Battery 25R Flat Top, Real 2500mAh.**

After removing the 6 torques that are securing the back casing of the tool you will have access to the batteries. Please note direction of the orientation prior to removing the batteries.

After installing the new batteries and securing the rear casing, make sure to check the red stop button on the front, as it may have been pressed while the tool was turned over during maintenance.
